UPDATED CAPITAL RESERVE ANALYSIS
FOR
AUSTIN LAKE SUBDIVISION
SMYRNA, GEORGIA

PREPARED BY: MICHAEL W. MOREY, R.S.

JANUARY 2008

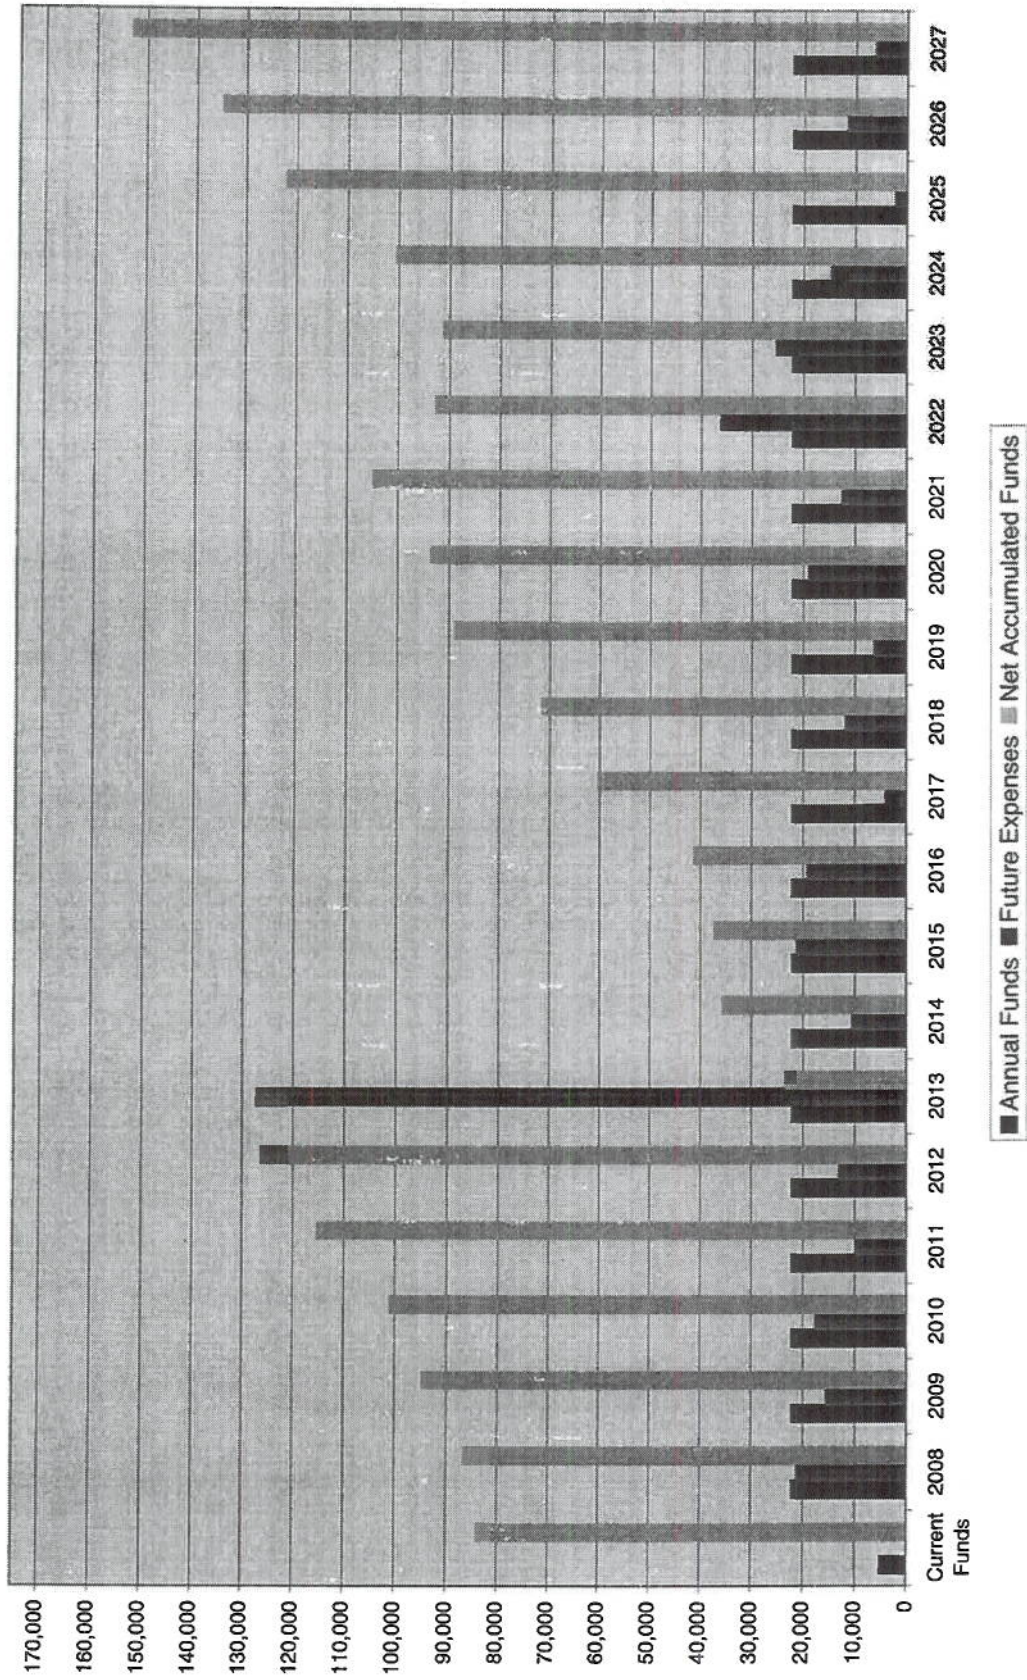
AUSTIN LAKE - PROJECTED CASH FLOW

The projected cash flow for the Capital Reserve Analysis is illustrated by the bar graph and line chart on the following pages.

The enclosed chart and graph contain a 20-year cash flow projection of the reserve requirements for the Association. The budget should be adjusted at the end of the 20-year period to readjust for changes in remaining life, inflation, and current costs of replacements. This cash flow analysis is based on the assumption that all of the items that make up the schedule are fully funded. By this we mean that each item will accumulate its full replacement cost during its life span. At the end of this life, each item would be replaced and the funding would start aging for items with a long life. For items with a short useful life, the funding for the first replacement is budgeted in addition to future replacements due to the short life span. The future replacement funding is started in the first year; however, payments are less than the first replacement due to the extended time period allowed to accumulate funds. Taking all of the components that make up the reserve schedule, using this full funding analysis, there is typically an ongoing surplus in the reserve fund. This ensures that the Association will have a surplus at the end of the 10-year period. This is called the "pooling effect" and is represented by the upper line on the cash flow chart, which is designated as the "Net Cumulative Fund." The "Net Cumulative Fund" is calculated by taking the existing amount in the reserve fund at the time the reserve schedule is prepared, adding to it the yearly contribution, and subtracting from it the annual expenditures.
